## **A TOOLKIT FOR VACANT DANCE HALLS:** Keeping a dance hall in good condition when it is rarely used

ANN BENSON MCGLONE, LLC + PRESERVATION MATTERS

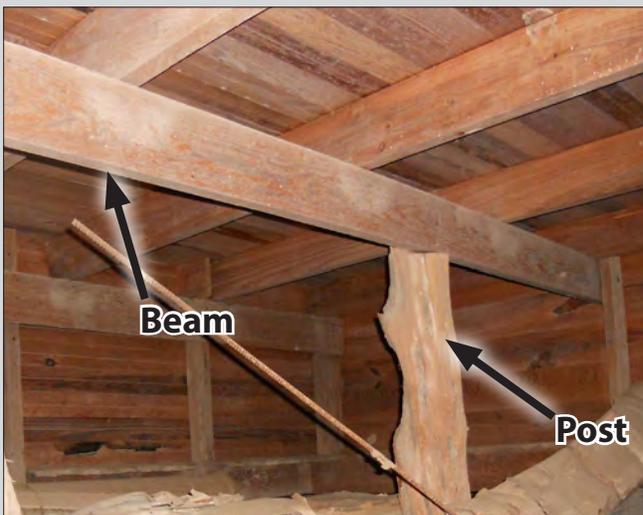
### Post and Beam

The simplest foundation system is a post and beam. Like the name implies there are posts that rest on the ground (or are buried in the ground) that hold up beams that span between the posts. Floor joists then rest on these beams. Sometimes the post rest on stones or concrete blocks. A typical foundation renovation might replace the wood posts with concrete posts.

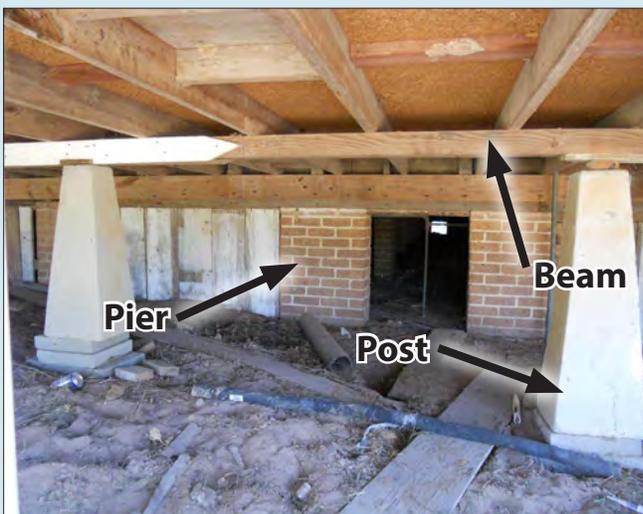
### Pier and Beams

Similar to post and beam construction, a pier and beam foundation rest on concrete or masonry piers which extend into the ground. These piers often have spread footings or bell shaped footings beneath the surface.

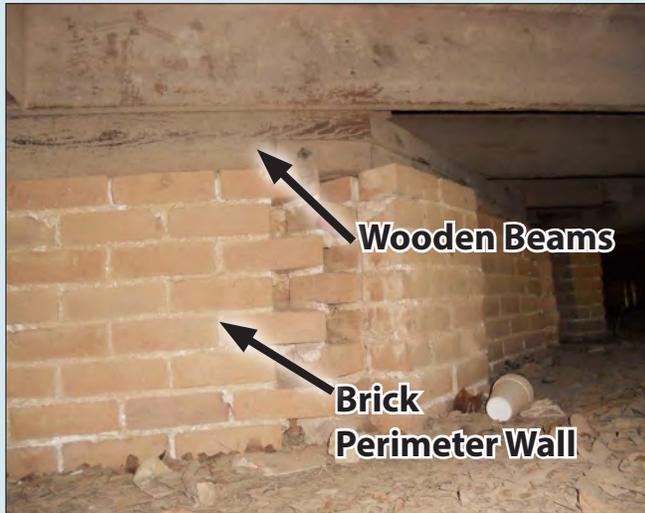
### **Perimeter Walls**

A continuous wall is laid around the perimeter of the building. Wooden beams rest on this perimeter wall and may span from side to side or on large structures to an intermediate interior concrete wall. Brick or stone are typical materials for the foundation. Recent walls may be constructed of concrete.

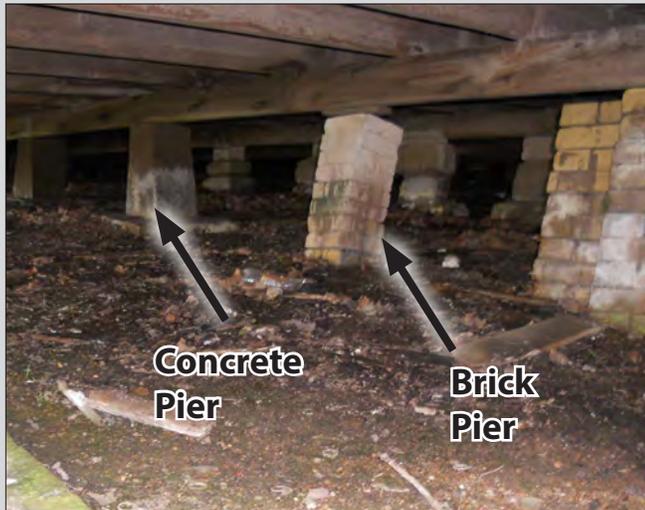
### **Foundations Using Different Materials**

Sometimes a dance hall may use more than one type of material in the foundation. This happens over time as different repairs are made on the building. It should be noted the carrying capacity of the different materials may vary.

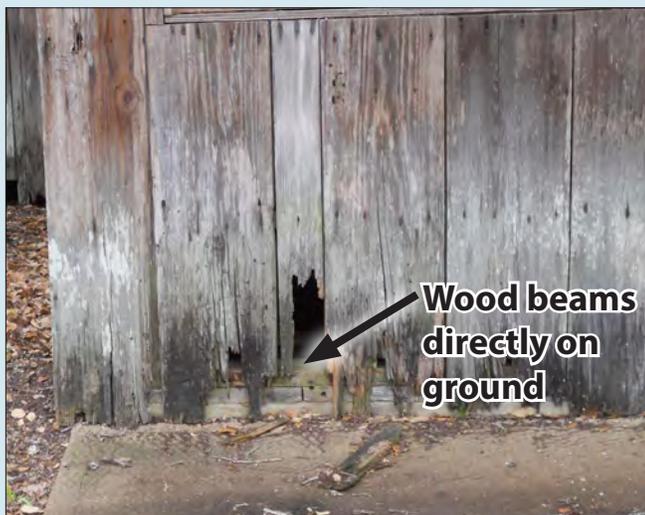
### **No Foundation**

Not all dance halls have foundations. Sometimes the wood floor beams or joists were laid directly on the ground. This makes the foundation more susceptible to deterioration from water or insects.

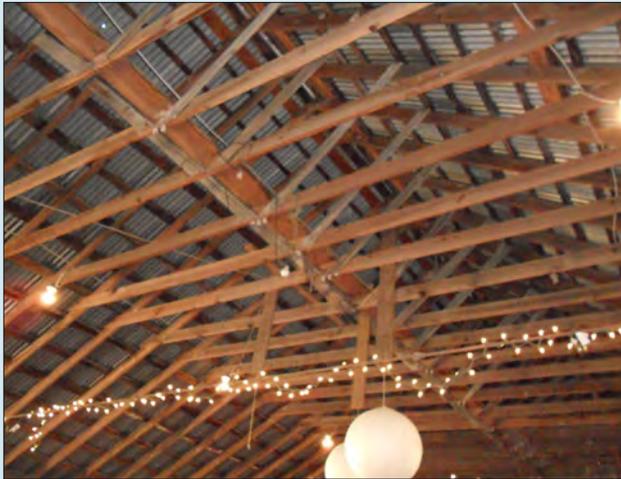
FIG. 1: Rafters or joists are spaced further apart than modern construction. Look for sagging beams or ridge lines.

An exterior visual inspection will reveal if the roof ridge is straight or if it is sagging. If a visual inspection of the roof shows that the ridge beam is bowing, or that there are visible valleys in the roof, it is important to identify the problem, then determine the cause. Listed below are common failures to look for inside the dance hall that cause sagging roof ridges or roof valleys.

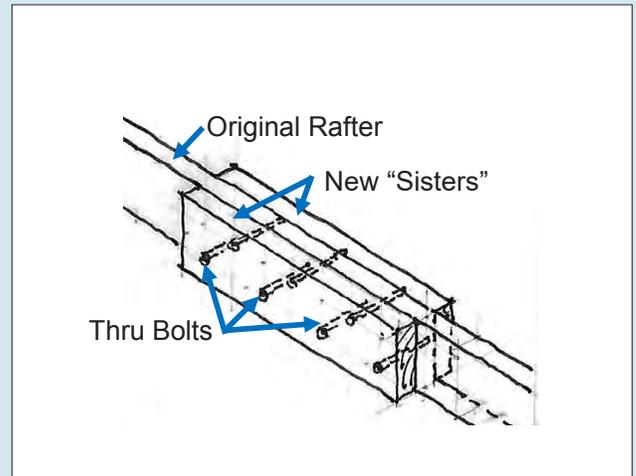
FIG. 3: Inadequate sized lumber used to span a distance. Causes sagging of beams. Add a piece of lumber to assist, called a “sister beam.”

- i. *Immediate:* Add a piece of wood equal in size to both sides of the original rafter. Bolt it in place. This is called a “sister” or “sistering.” The sister pieces should be long enough to help the original rafter bear on plates or beams. (FIG. 3)

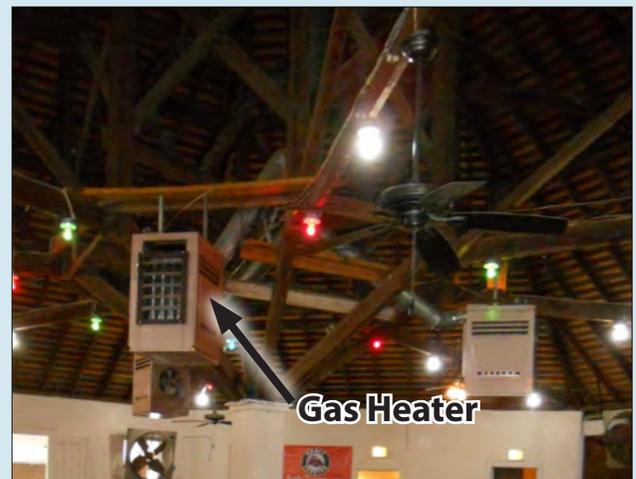
FIG. 4: Additional weight of gas heater could causes beam to sag.

Over the years fans, gas heaters, speakers, signs, or HVAC equipment have often been added to or hung off the original structure. Sometimes plywood sheathing and layers of old shingles contribute to the weight. The added weight can cause sagging.

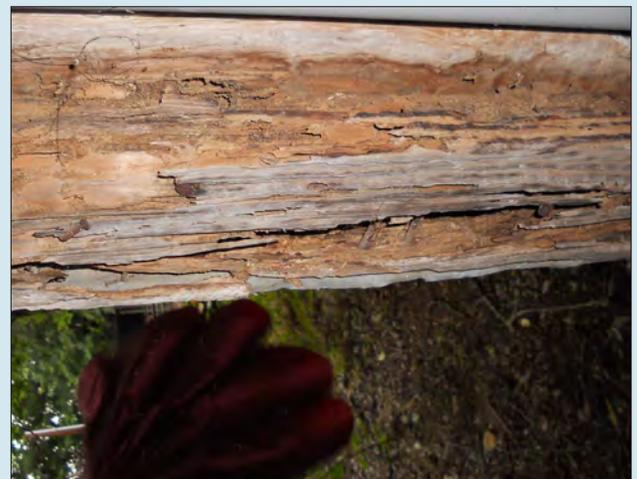
FIG. 5: Deterioration of wood member due to water damage or bugs.

Water damage from leaks in the roof or insects might have weakened the structural integrity of the roof members. (FIG. 5)

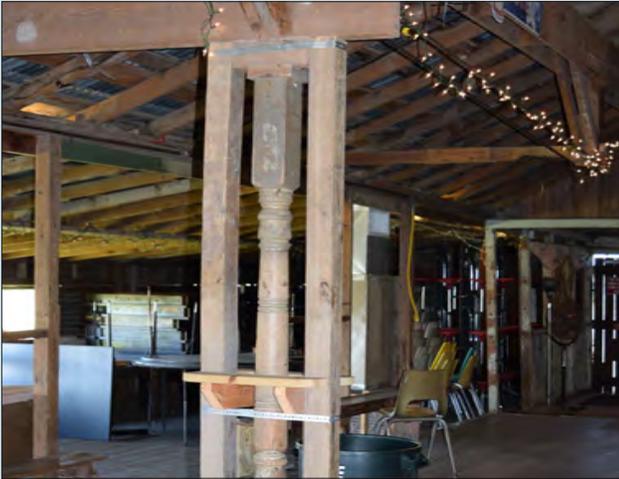
FIG. 6: Column between kitchen and dance floor has been modified. Modified columns may need to be reinforced.

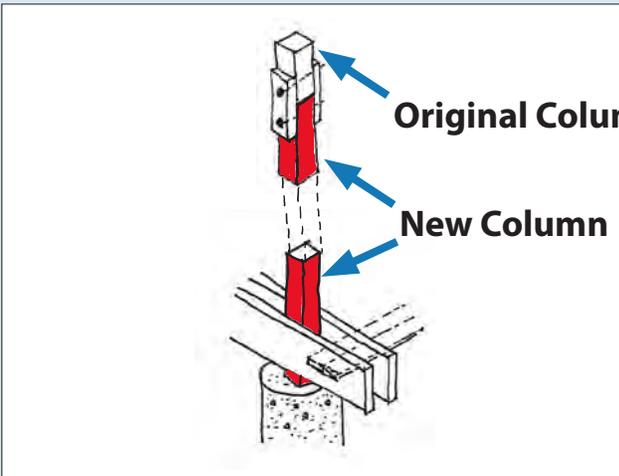
FIG. 8: When replacing a missing column, make sure the new column has a strong foundation and that it is securely attached to the existing piece of column.

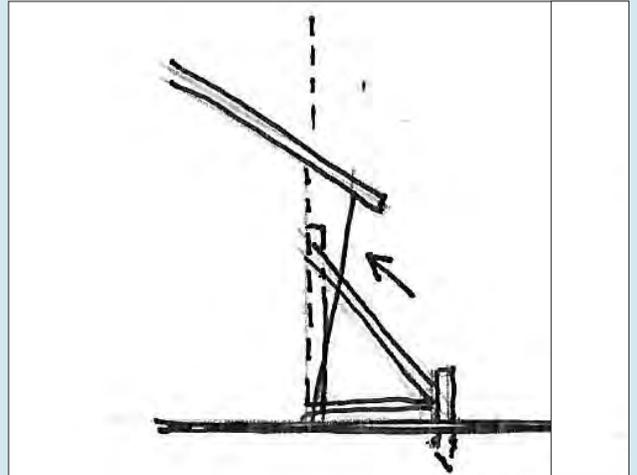
FIG. 9: Leaning buildings should be temporarily propped up until a more thorough solution can be found.

- i. *Immediate:* Prop up the leaning wall. This does not have to be complicated – simply wedge a 2X4 or 2X6 between the ground and the wall to keep the wall from leaning further. Placing a board across the face of the wall to give added support to the 2X4’s would assist in the stabilization the building. (FIG. 9, FIG. 10)
- ii. *Long Term:* Check the foundation and confirm that it is adequate. Consult a structural engineer or a qualified foundation company to make an assessment and provide advice on repairs required.

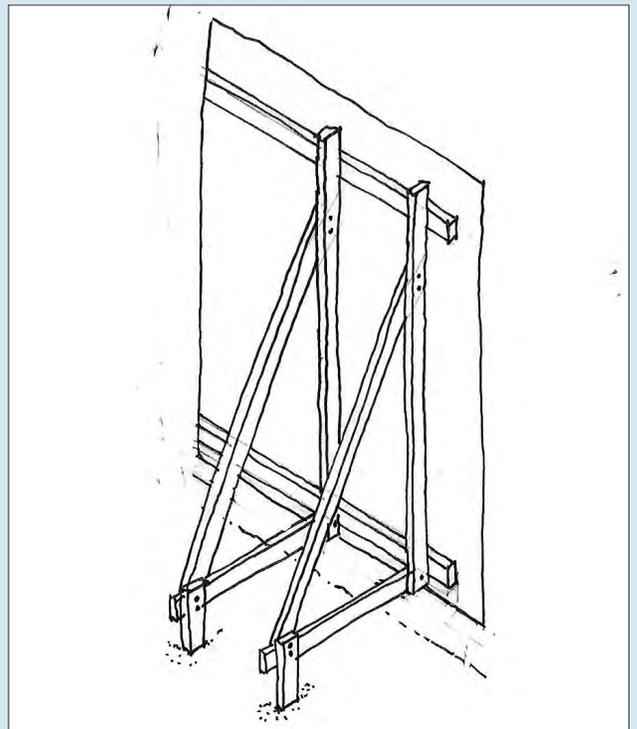
FIG. 10: Detail of bracing to stabilize a wall.

- i. *Immediate:* Brace the walls with 2X4’s or 2X6’s. X bracing may help stabilize the walls. Or Y bracing at the columns, may help to distribute the load. (FIG. 10)
- ii. *Long Term:* A structural engineer should assess the structural forces on the walls or columns and make recommendations.

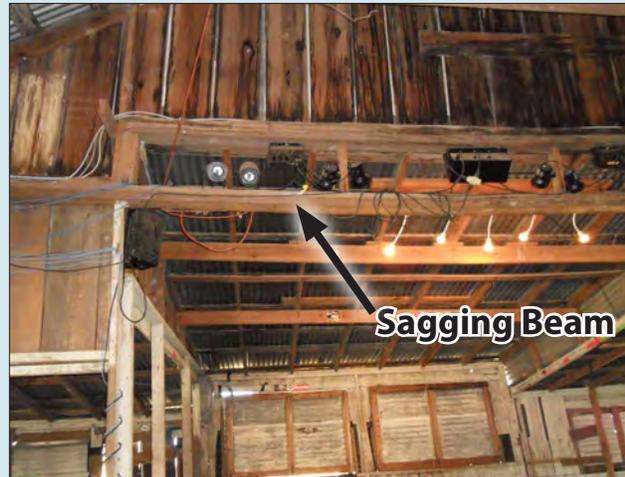
FIG. 11: Bearing wall removed to expand stage. Note sagging beam, add support post.

- i. *Immediate:* Add support posts beneath the beam where the wall used to be. It is wise to make sure the new posts align with adequate support below the floor. In the case of an opening, insert posts if there is something to bear on like a supported counter or add a beam across the top that bears on a solid wall on either side of the opening. (FIG. 12)
- ii. *Long Term:* A structural engineer should assess the structure and make recommendations. Generally, they will be able to tell if the immediate solution is adequate.

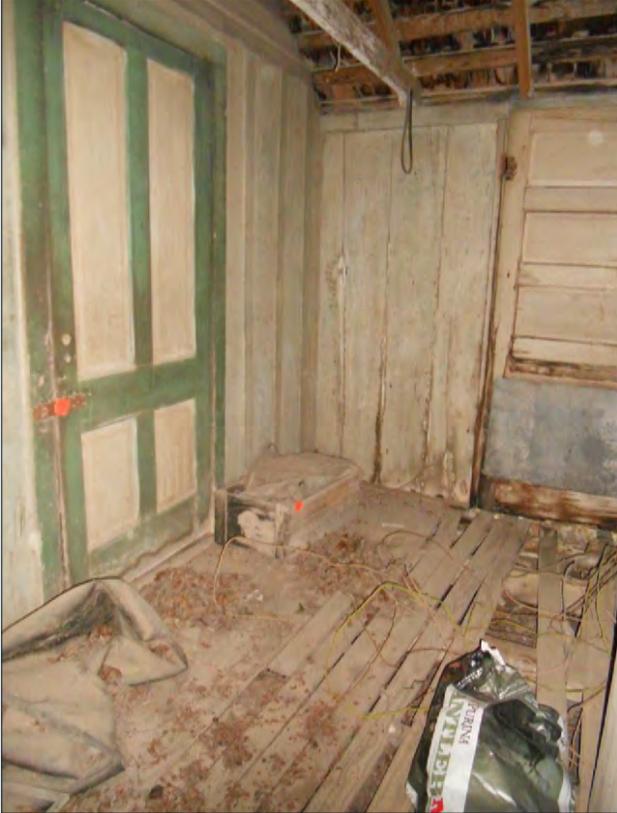
FIG. 13: Deteriorating bearing walls. Note damage to the floor as well.

A bearing wall located beside a restroom or kitchen may also be a plumbing wall. Leaks in the plumbing over time may have caused serious damage to the bearing capacity of the wall. (FIG. 13)

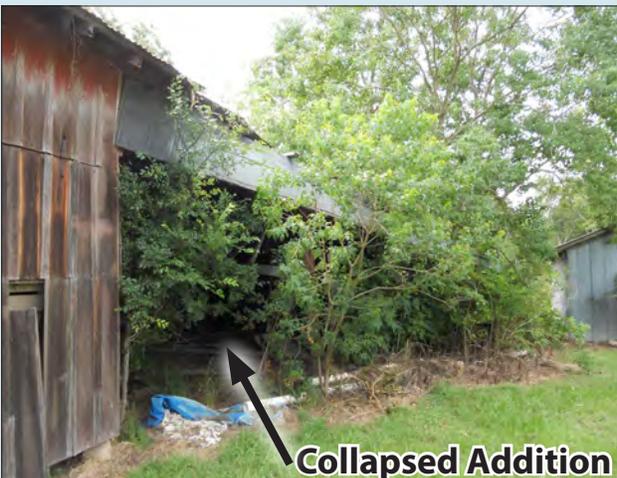
FIG. 14: Collapsed addition. Remove if possible, to stop drag on main building.

Sometimes on a vacant building a non-load bearing wall has failed or an addition collapsed. This can put additional strain on interior bearing walls. (FIG. 14)

- i. Immediate:* Remove the collapsed addition or failed wall to relieve the strain on the building structure.

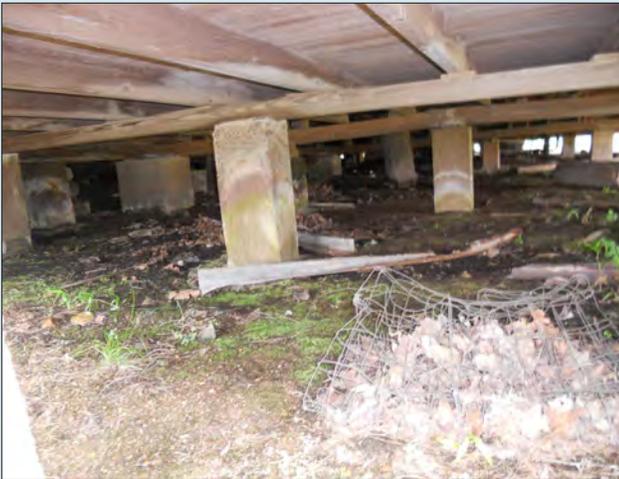
FIG. 15: Shifting foundation may place support columns at awkward angles. Monitor with plumb bob from top of post.

Over time, a dance hall's foundation may have shifted. This could be due to varying soil conditions, weight distribution, severe weather exposure (such as tornadoes or hurricanes), active water under the building, or other stresses on the building. Looking under the building, the posts will be at awkward angles, rather than vertical and in plumb. (FIG. 15, FIG. 16)

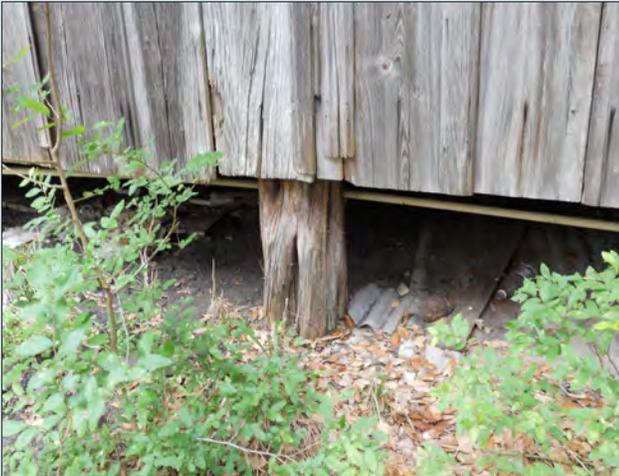
FIG. 16: Wood foundation post on ground exposed to active water. Keep dry to prevent rot. Note rotting post.

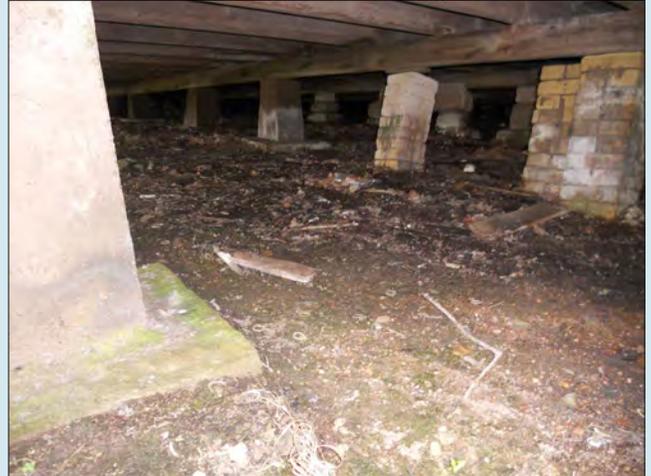
FIG. 17: Unsupported beam due to shifted column. Note brick post above has shifted, causing unsupported beam.

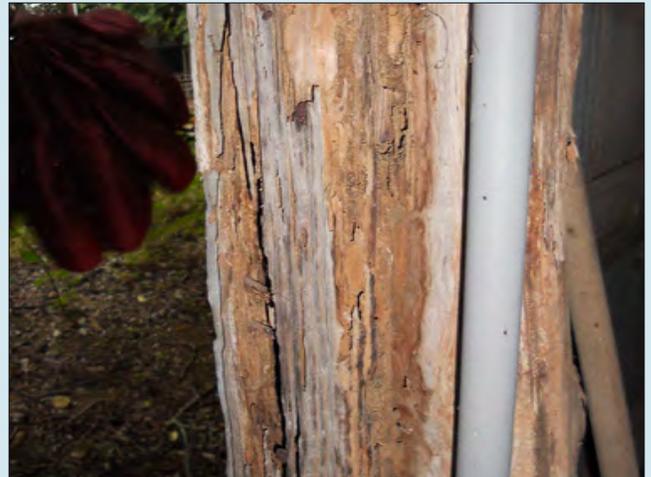
FIG. 18: Rotting post due to moisture.

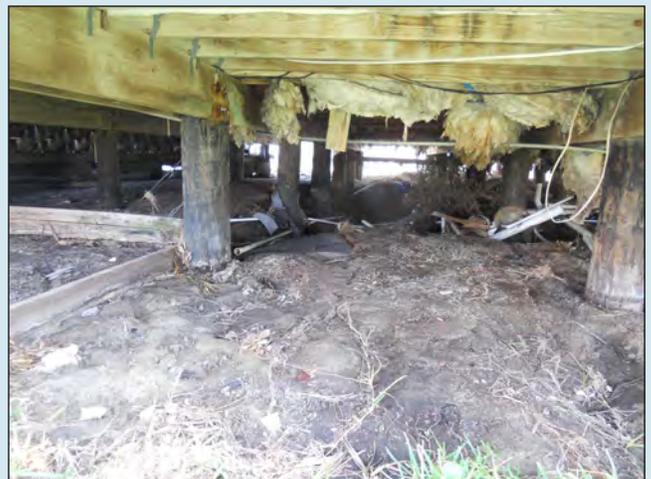
FIG. 19: Water erosion due to flooding under dance hall.

If surface water from a rain event is allowed to run under the dance hall, it has the potential to erode the soil around a foundation or buried posts. (FIG. 19)

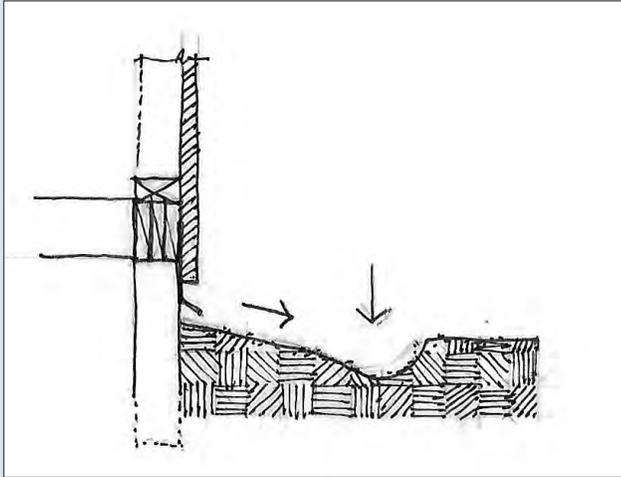
FIG. 20: Create a trench to keep water away from the building foundation.

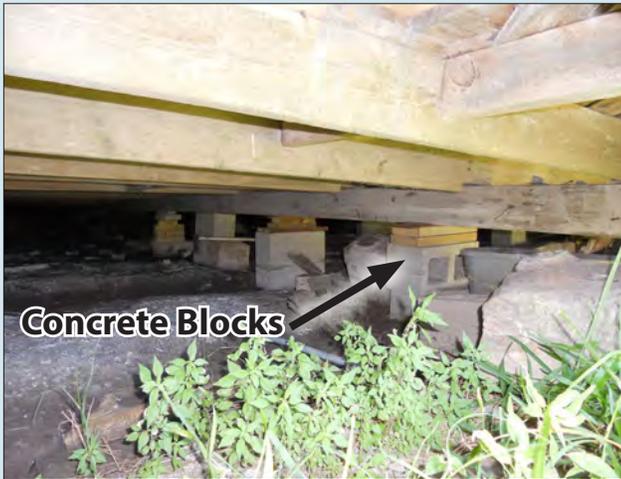
FIG. 21: Inadequate footing: concrete blocks can collapse.

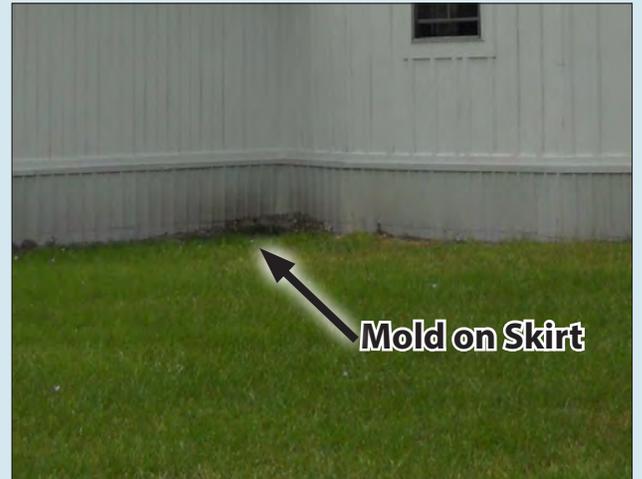
FIG. 22: Skirting is attractive but may hinder proper ventilation of foundation to keep it dry. Note mold on skirting, indicating moisture.

- i. Immediate:* Don't put a solid apron around the building to hide the elevated foundation. Lattice-like aprons are fine or vents placed around the perimeter to allow for air circulation. (FIG. 23)
- ii. Long Term:* Install non-rotting building aprons (metal or cementitious board) that extend at least twelve inches into the ground to keep animals out. Add vents for proper circulation.

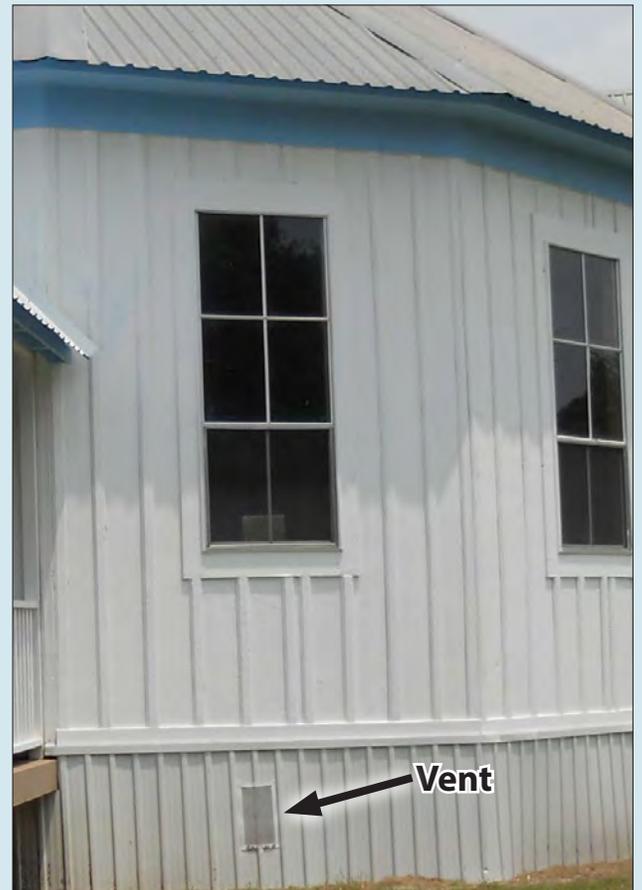
FIG. 23: A larger vent is recommended to increase air circulation within the foundation and under the dance hall.

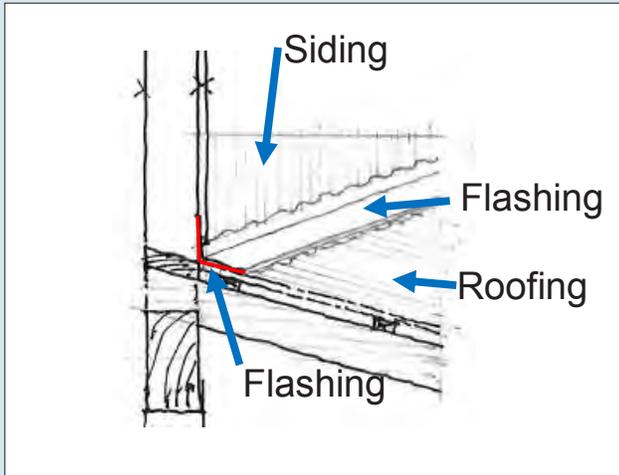
FIG. 24: Section showing flashing detail.

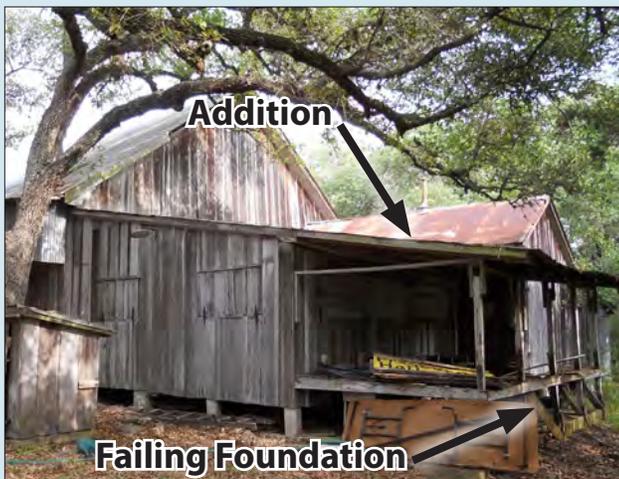
FIG. 25: Addition with failing foundation.

If the addition was hastily built, or was originally intended as a temporary structure (such as a shade structure that was eventually enclosed) there may be no foundation or the floor joist might be sitting directly on the ground. (FIG. 25)

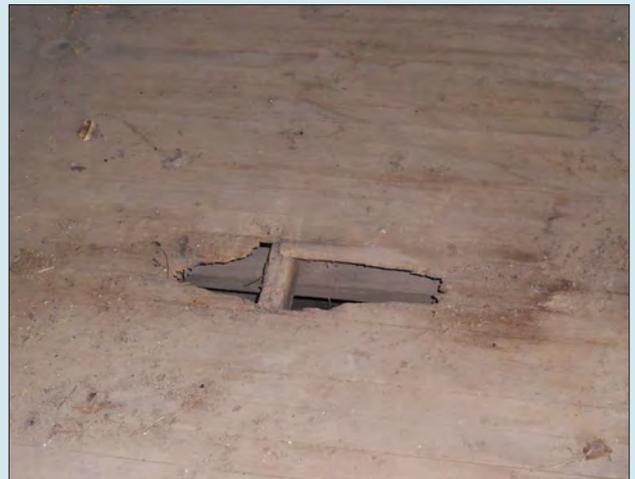
FIG. 26: Hole in the floor caused by leaking roof.

- i. Immediate:* Identify the source of the problem such as a leaky roof or a poor foundation and then solve the cause of the problem. Cover the damaged area with plywood to prevent someone from stepping through the hole or damaged floor.
- ii. Long Term:* Replace the damaged floor with wood flooring that is the same species and size.

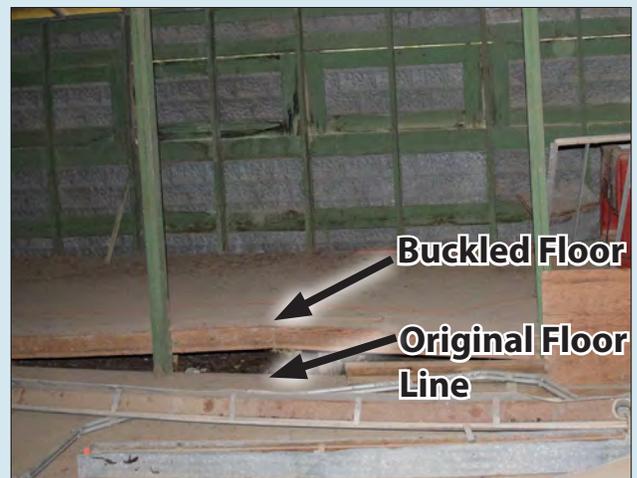
FIG. 27: Floor to left of the center post is buckling upward, which may be result of leaking roof or shift in the foundation.

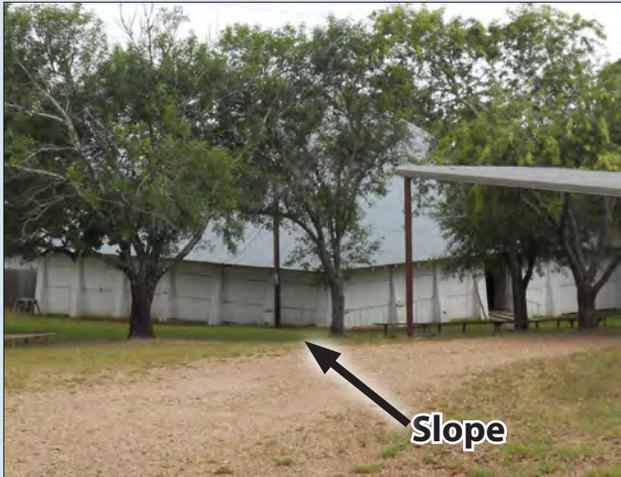
FIG. 28: Downhill slope to corner of dance hall will cause problem of pooling water against building.

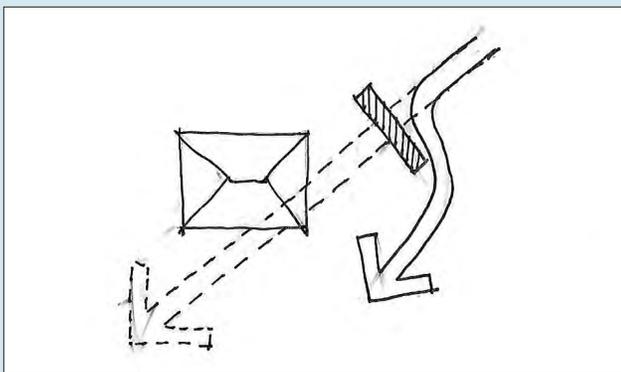
FIG. 29: Create a small dam to divert water from the building foundation.

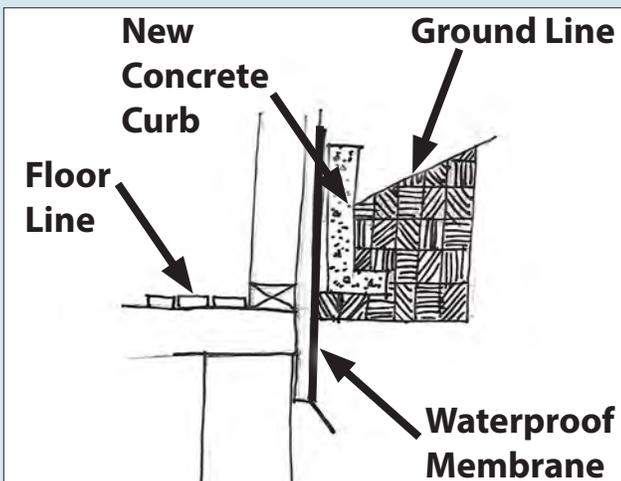
FIG. 30: For soil above floor line add waterproof membrane and a concrete curb.

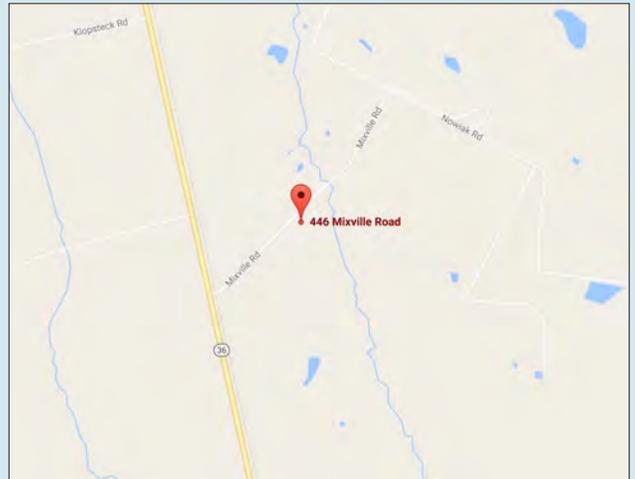
FIG. 31: Dance hall near Allen's Creek that is prone to flooding.

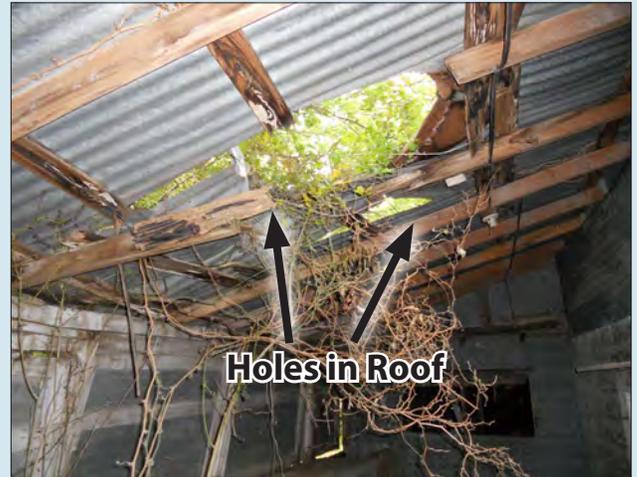
FIG. 34: Holes in the roof need immediate repair.

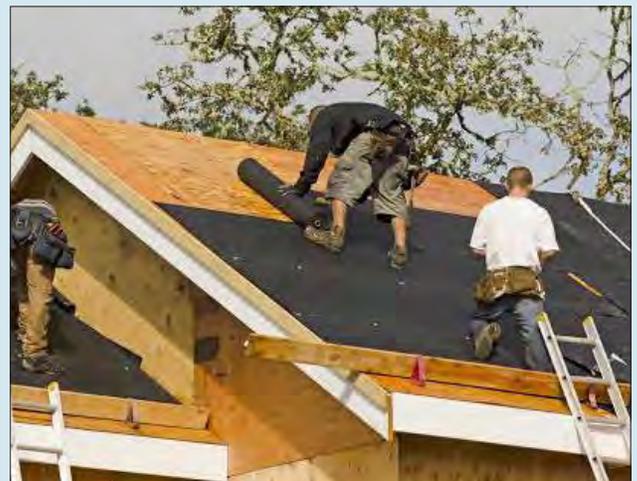
FIG. 35: A tar paper patch is a quick fix.

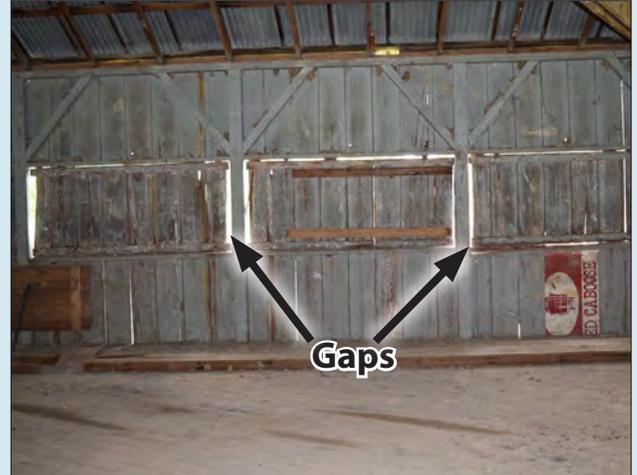
FIG. 39: Dance halls often have gaps between walls and shutters.

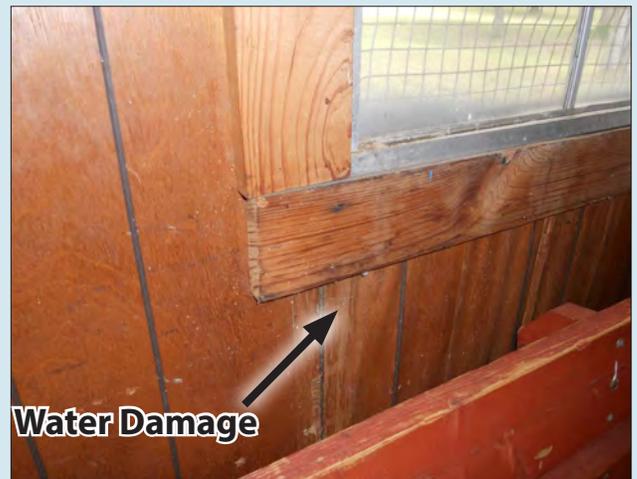
FIG. 40: Water damage below windowsill due to improper flashing

- i. *Immediate:* Cover the windows on the outside with heavy duty plastic sheeting and hold in place with 1X4 nailers. This will keep water from running down the face of the window and leaking into the walls. Make sure the vinyl and nailers extend at least 4 inches beyond the window in all directions.
- ii. *Long Term:* The windows will need to be removed and proper flashing installed.

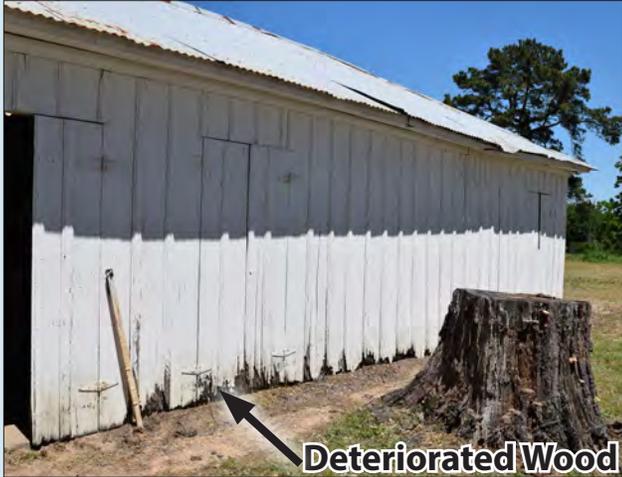
FIG. 41: Deteriorated wood siding allowing water into building.

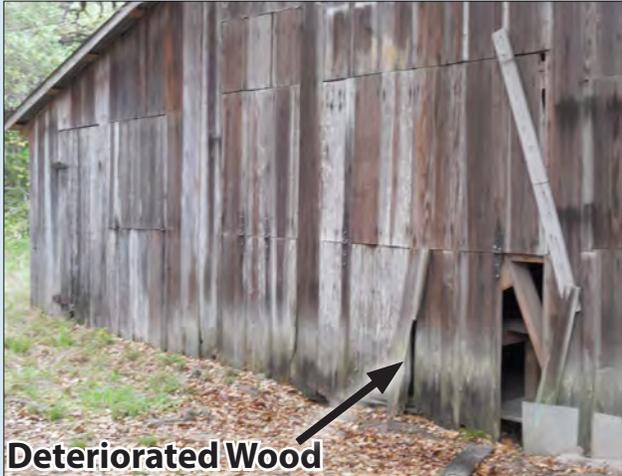
FIG. 42: Deteriorated wood siding and holes in the walls allowing water into building.

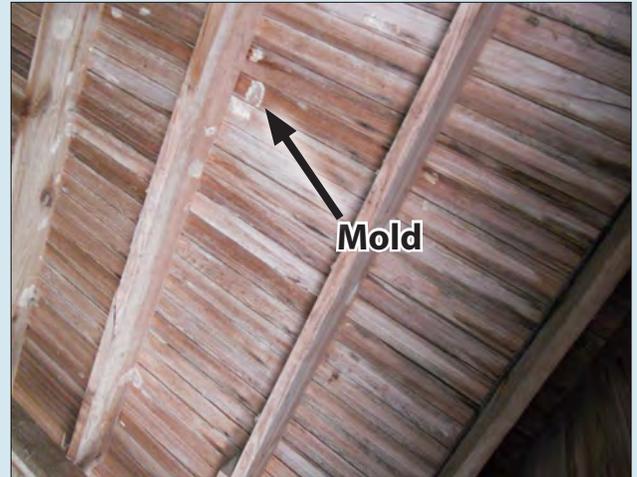
FIG. 43: Mold on roof

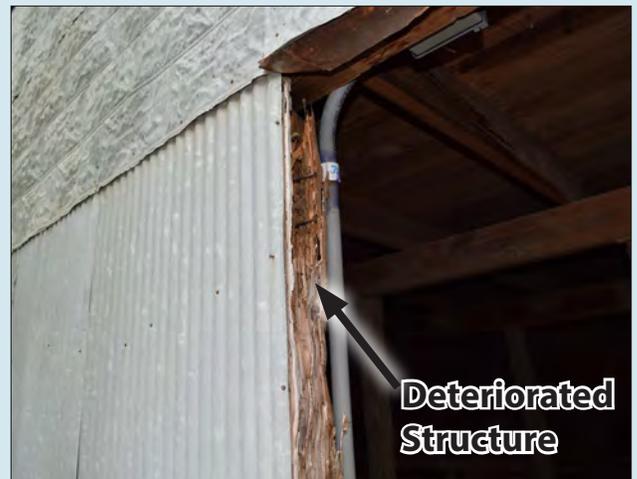
FIG. 44: Deteriorated structure from dry rot.

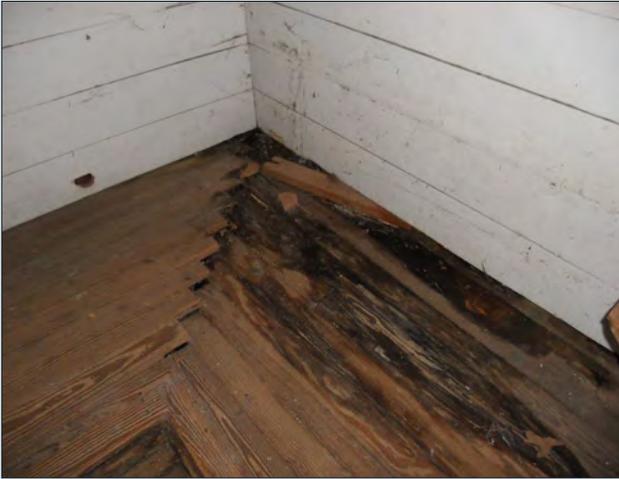
FIG. 45: Deteriorated floor. Located below exterior grade.

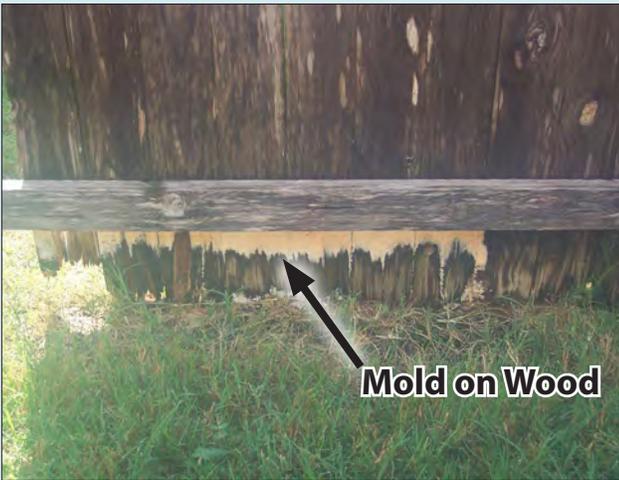
FIG. 46: Mold growing on old wood.

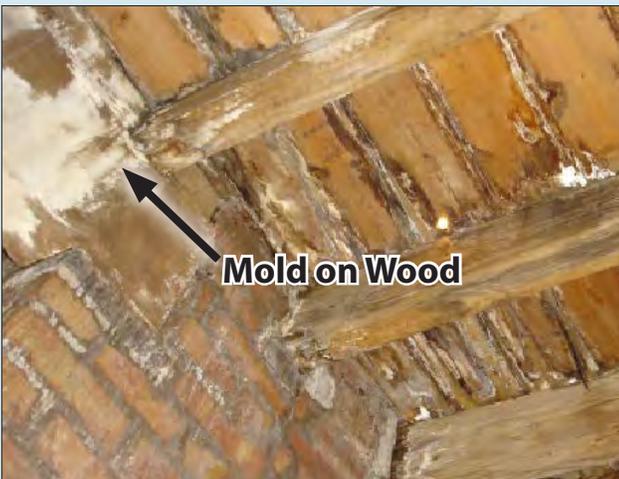
FIG. 47: Mold growing on old roof.

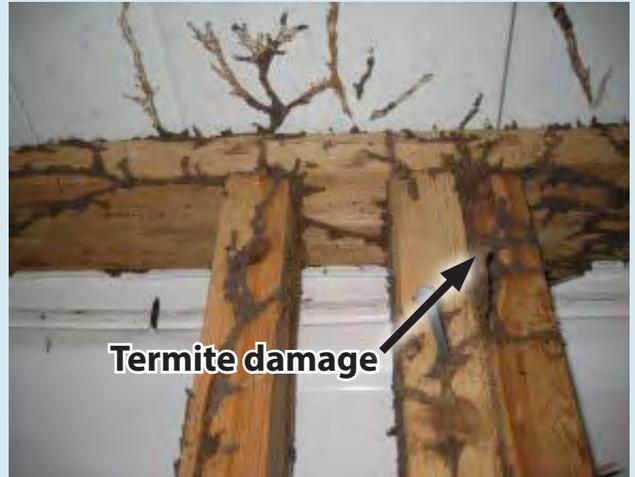
FIG. 48: Damage caused by termites.

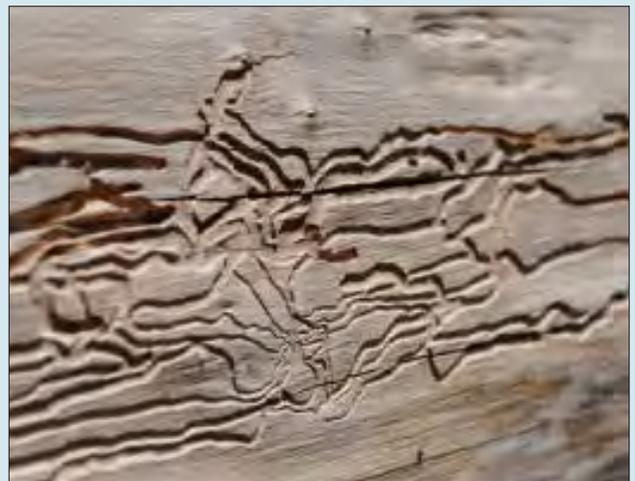
FIG. 49: Termite paths in wall.

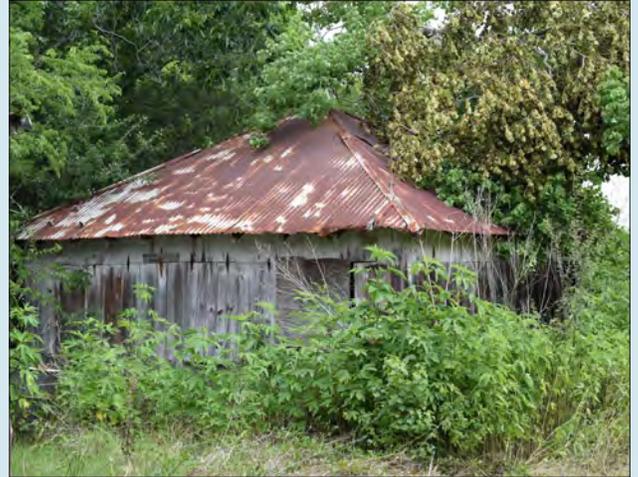
FIG. 53: Structure surrounded by vegetation

- i. Immediate:* Clear off all climbing plants that cover the walls. For ivies, and other climbing plants, snip their stems (at the base of the plant) so that they die. After the leaves turn brown, they are easily removed.
- ii. Long Term:* Remove trees and plants that are too close to the building where they can rub on roofs and damage walls and foundations. A registered arborist can trim tree canopies and spot heavy limbs that will become a hazard to the dance hall roof.

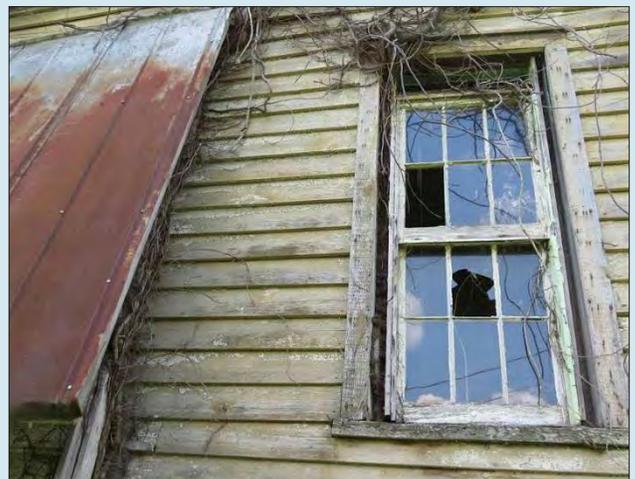
FIG. 57: Broken windows on abandoned building.

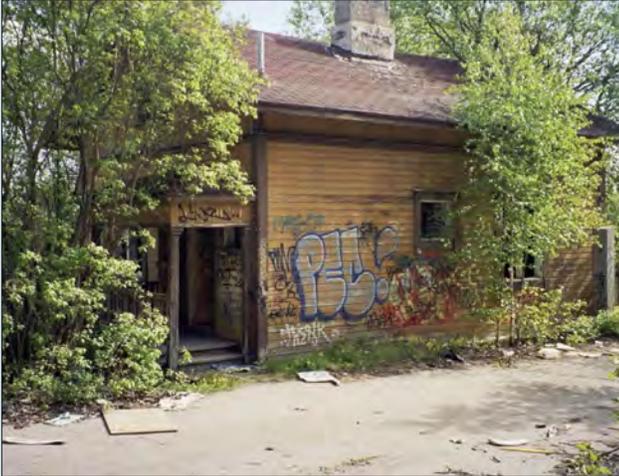
FIG. 58: Graffiti on abandoned building.

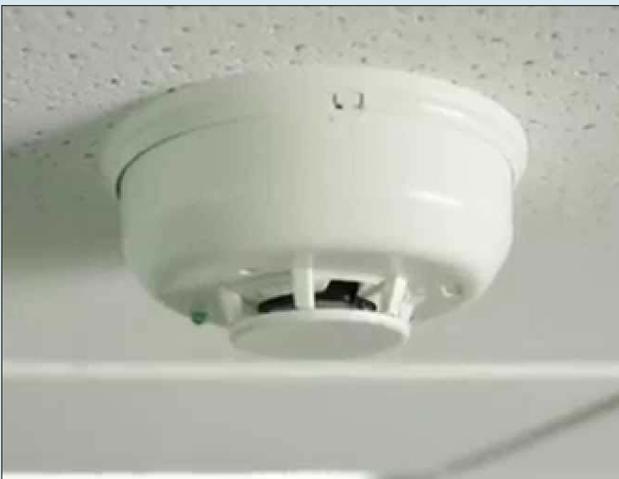
FIG. 60: Smoke detector

- i. Immediate:* Lightning rods that are properly grounded should be a first consideration. (FIG. 59) Also install a fire extinguisher. Smoke detectors that use battery packs can be remotely linked to cell phones or horn systems. (FIG. 60)
- ii. Long Term:* Consider investing in a sprinkler system. Check that electrical wiring has been renewed to prevent short outs, as they are a fire hazard. Remove flammable materials like paints, paint removers, and cleaning products.

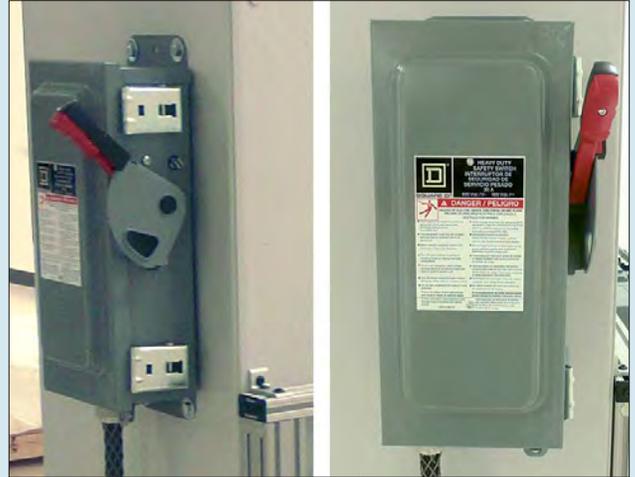
FIG. 61: Electrical box with disconnect.

- i. *Immediate:* If building is not going to be heated, then drain water tanks, toilets, and pipes and then add glycol to the water as an “anti-freeze.” This will prevent broken pipes that may burst with expansion in freezing weather. Gas systems with open flames should be turned off. Have the utility company shut off gas lines.
- ii. *Long Term:* Install a single-source, cut off point for all electric power if the dance hall is to be vacant for an extended period of time. Consider updating wiring systems and electrical boxes if the wiring is unsafe.
